PROPERTY INSPECTION REPORT

Tri Summit Home Inspections, LLC

123 Anytown

Date of Inspection: 6/9/2022

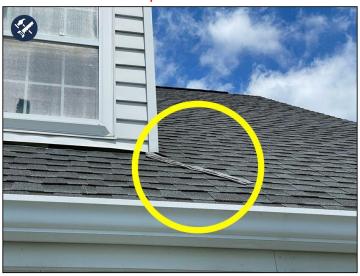
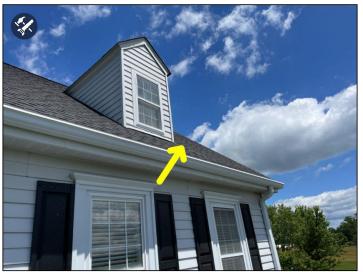
1. Roof Condition

• At the time of this inspection, I observed that a shingle underneath the west facing right side window has come loose and is falling away. It is recommended that a qualified roofer further evaluate and repair as needed.

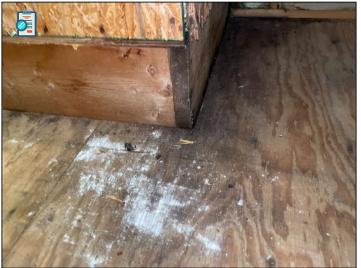
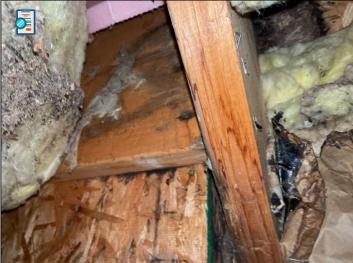
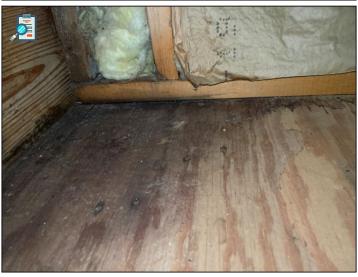
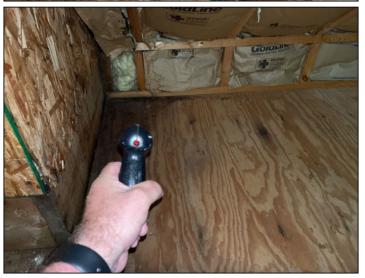
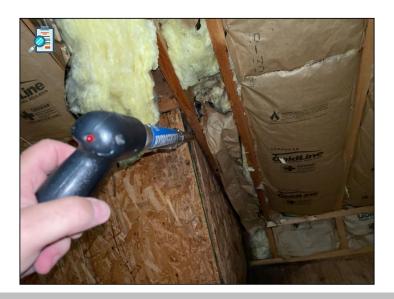
- The entire structure to the attic was not visible due to insulation coverings and finishes.
- At the time of this inspection, I observed what appeared to be prior water staining from a leak on the roof. This area is located in the south facing closet in the 2nd floor bonus room. It tested dry at the time of this inspection.

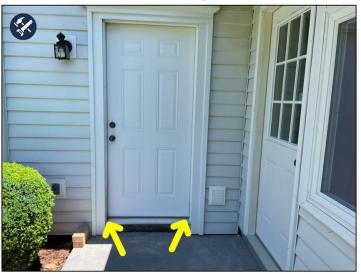
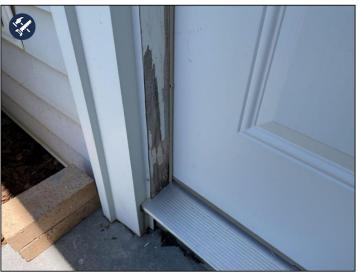
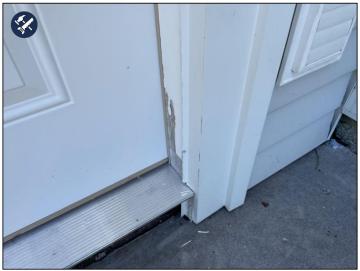
- Metal doors were noted.
- At the time of this inspection, I observed that the garage back door requires painting on the outside trim in order to protect wood underneath.

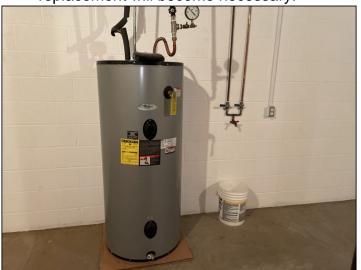
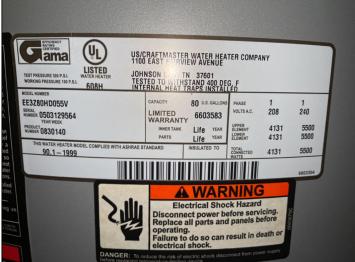
1. Water Heater Condition

Deferred Cost Item: Water heaters have a typical life expectancy of 7 to 12 years. The
existing unit is approaching this age range. One cannot predict with certainty when
replacement will become necessary.

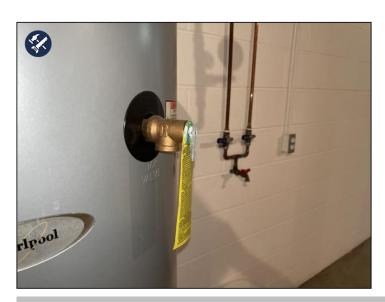
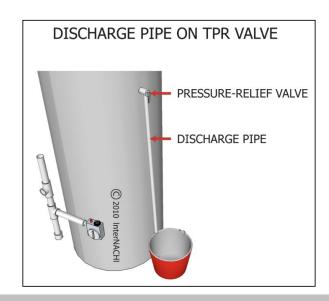
4. TPRV Condition

• The discharge pipe for the **IPR valve** is not long enough or not installed. The discharge pipe should terminate between 6 and 24 from the floor.

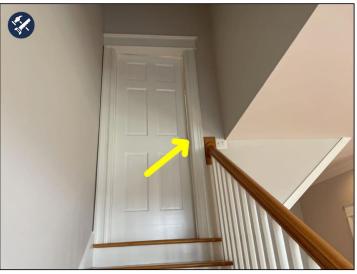
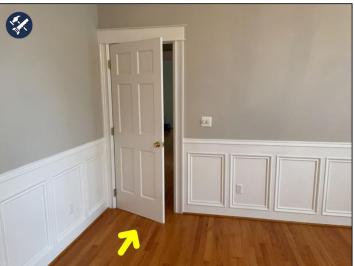
4. Doors Condition

Inte	Interior Areas				
	Page 27 Item: 4	Doors Condition	 The door leading to the third floor at the top of the stairs will not latch in the closed position. Minor hardware adjustments are needed on the striker plate. The door to the first floor south west formal room rubs along the bottom on the wood floor. Minor trimming as needed.

- The door leading to the third floor at the top of the stairs will not latch in the closed position. Minor hardware adjustments are needed on the striker plate.
- The door to the first floor south west formal room rubs along the bottom on the wood floor. Minor trimming as needed.

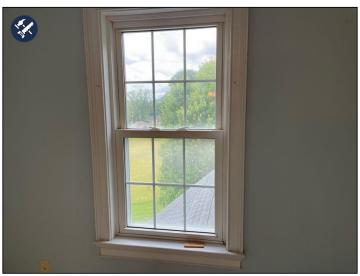
5. Window Condition

Page 28 Item: 5	Window Condition	 The west facing upstairs third-floor window will not stay up on its own. It is the window just to the left of the half bath. Many of the interior windows were difficult to open and close. Lubrication may need to be applied. If that does not work, then a qualified window specialist should further evaluate and repair as needed.
	Page 28 Item: 7	Smoke Detectors	• The smoke alarms appeared to be hooked up to a central alarm system and were therefore not tested. It is recommended that they be demonstrated for functionality during the final walk-through.
	Page 28 Item: 8	Stairs & Handrail	• At the time of this inspection, I observed that the handrail with balusters on the third floor was very loose. It is recommended that it be better secured to the floor for safety reasons.
	Page 29 Item: 10	Ceiling Condition	• At the time of this inspection, I observed a considerable amount of nail popping in the upstairs bonus room. It may be desirable to have a licensed contractor or qualified drywall specialist further evaluate and repair as needed.

- The west facing upstairs third-floor window will not stay up on its own. It is the window just to the left of the half bath.
- Many of the interior windows were difficult to open and close. Lubrication may need to be applied. If that does not work, then a qualified window specialist should further evaluate and repair as needed.

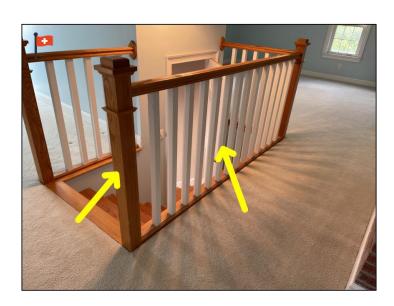
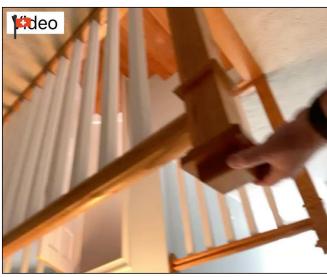
• At the time of this inspection, I observed that the handrail with balusters on the third floor was very loose. It is recommended that it be better secured to the floor for safety reasons.

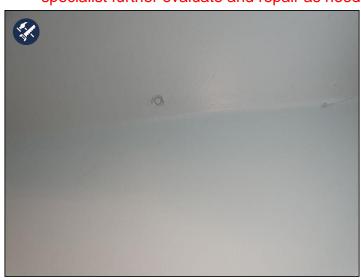
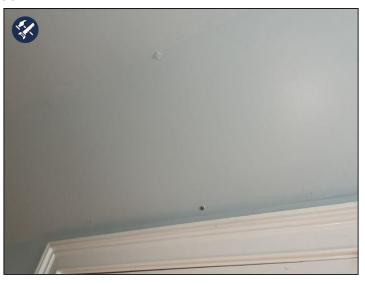
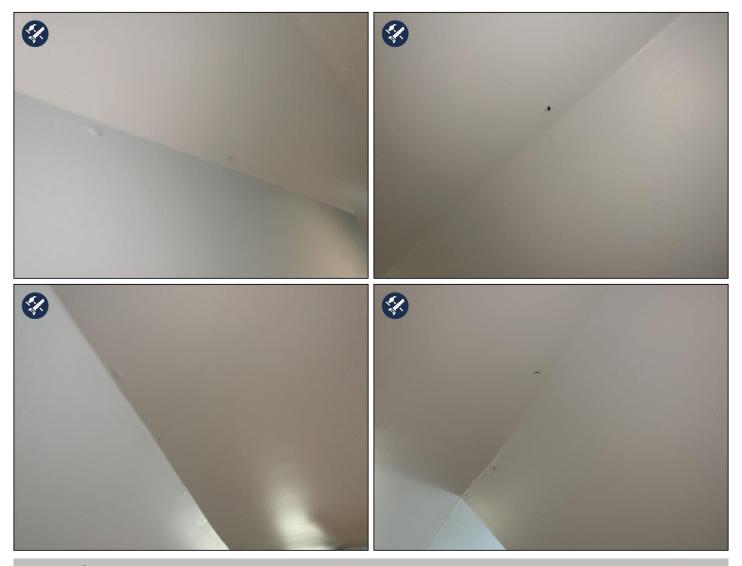
10. Ceiling Condition

• At the time of this inspection, I observed a considerable amount of nail popping in the upstairs bonus room. It may be desirable to have a licensed contractor or qualified drywall specialist further evaluate and repair as needed.

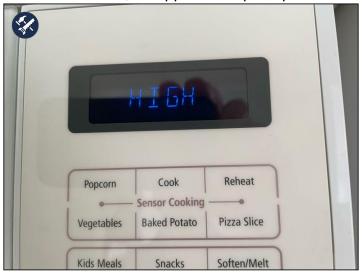
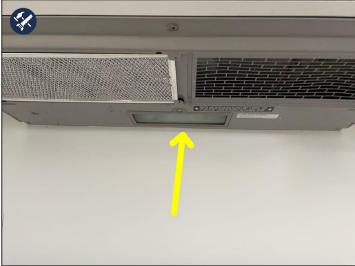
- Built-in microwave ovens are tested using normal operating controls. Unit was tested and appeared to be serviceable at time of inspection. Leak and/or efficiency testing is beyond the scope of this inspection. If concerned, client should seek further review by qualified technician prior to closing.
- The microwave light for the cook top was inoperable at the time of the inspection. If the bulb is not blown, an appliance repair specialist should be consulted.

If the bulb is not blown, then an appliance repair specialist should further evaluate and repair as needed.
