PROPERTY INSPECTION REPORT

Tri Summit Home Inspections, LLC

123 Anytown

Date of Inspection: 6/9/2022

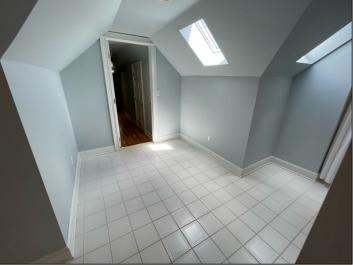
- At the time of this inspection, I observed no visual signs of defects.
- Skylight in bathroom,(see pic)did not display any outward signs of active or past leaks.

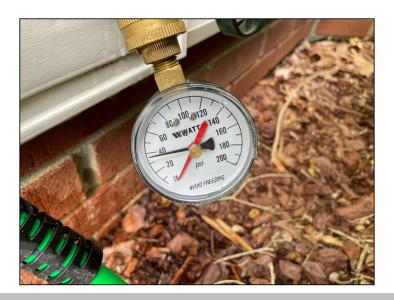
• 35 PSI

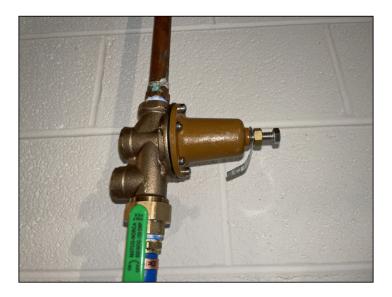
2. Pressure Regulator

• A pressure reducing valve was noted in the basement.

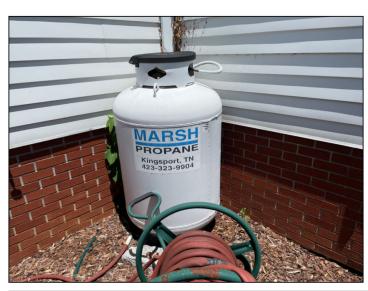
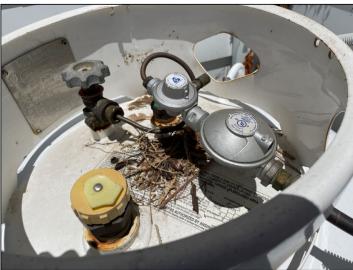
Materials: The main gas LP shut off can be found near the regulator, which is located on the West side of the home.

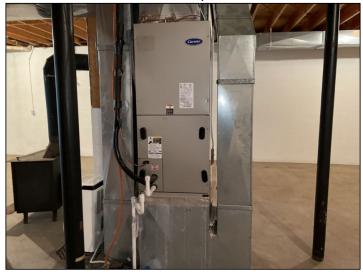
Materials: Heat pump noted. • Manufacturer Carrier • Serial Number:Left side unit: 2013E27195; Right side unit: 1913E12472 • The home has a split system.

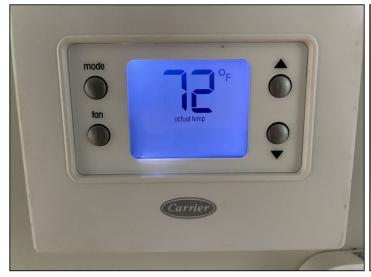
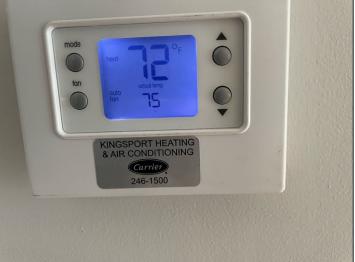
8. Thermostats

• The thermostat was functional at the time of inspection.

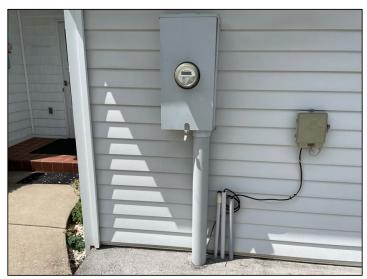
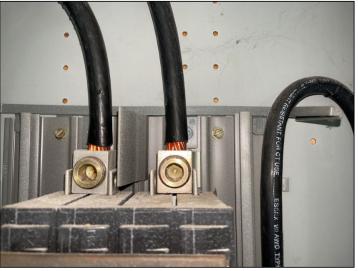
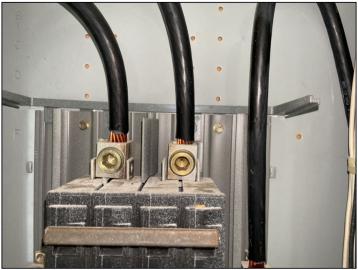
- There is an underground service lateral noted.
- Copper service entrance conductors noted.

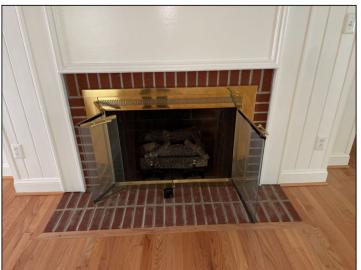
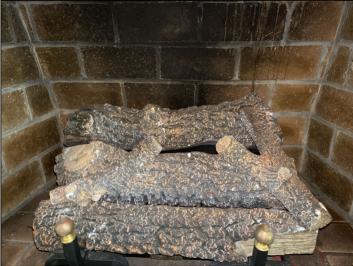
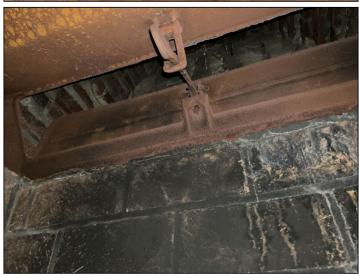
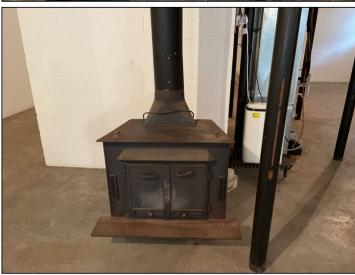
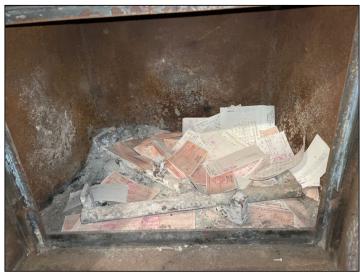
Materials: Masonry fireplace noted. • Pot belly style wood burning stove noted in the basement.

- At the time of this inspection, I observed no visual signs of defects.
- Damper was opened and closed several times.
- As a general rule, we do not like fire in the fireplace nor turn on gas. It is recommended that the functionality of the fireplace be tested during the final walk-through.
